# Case involving exposure to hydrogen chloride gas produced due to incorrect disposal of reagent used in semiconductor component manufacturing plant

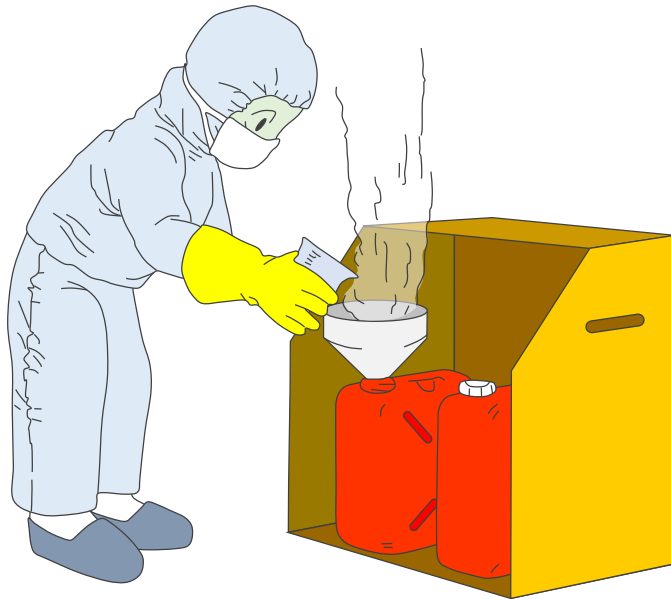
The washing process before the film formation process used a solution M, consisting of a mixture of sulfuric acid, hydrogen peroxide, and distilled water. The marking process used a solution N, consisting of a mixture of phosphoric acid and hydrochloric acid. Solutions M and N are normally processed separately, but hydrogen chloride gas was generated after solution N was accidentally poured into a plastic tank used to recover solution M.

The hydrogen chloride gas emitted from the plastic tank as white vapor spread throughout the cleanroom. Three workers in the room reported eye pain and received medical attention.

[3] The plastic tanks used to recover waste liquids must be properly capped or appropriate exhaust systems provided to ensure that any chemical vapor does not leak into work areas.

We recommend installing alarm systems to promptly detect toxic gas leaks in locations subject to chemical vapor leaks — for example, rooms in which waste liquid containers are kept.
